TECHNICAL ASSISTANCE TEAM FOR EMERGENCY RESPONSE REMOVAL AND PREVENTION
EPA CONTRACT 68-01-6669

January 19, 1987

TAT-05-F-01255

Re: Site Assessment of the TaraCorp Facility
McCook, Illinois
TDD# 5-8701-18 (FY 87)
TDD# 5-8612-49 (FY 87)
TDD# 5-8610-63 (FY 86)
TDD# 5-8608-01 (FY 86)

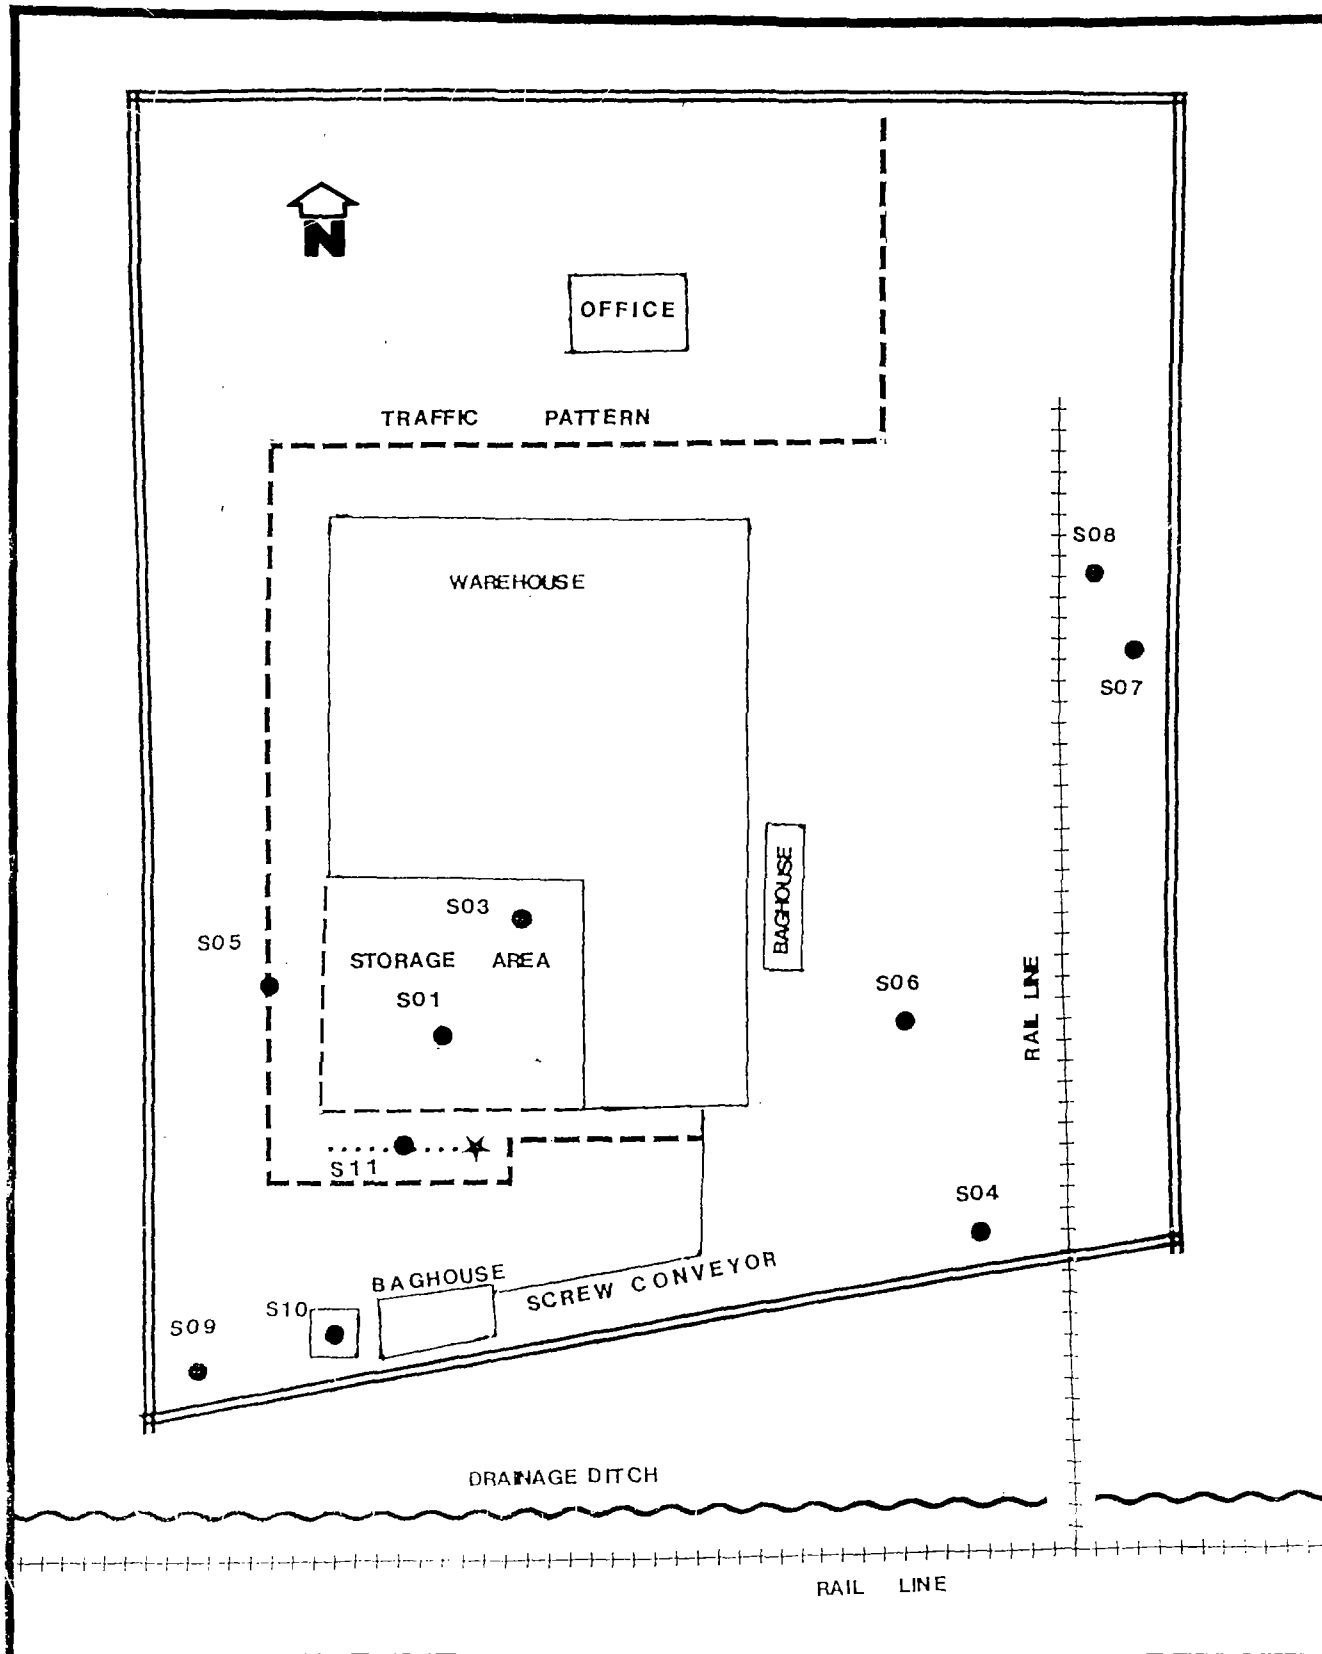
FIGURE 3

Soil samples were collected at locations listed in Table 1 and shown in Figure 3 and analyzed for total metals. Samples S01 and S04 were also analyzed for EP toxicity metals.

limit for typical soils. The sample from the area of broken battery casings near the railroad spur (S08) contained the highest lead level at the site (68%).
